# Berrien County Road Department Makes Positive Impact with Hill Road Bridge Improvements

**October 27, 2020**

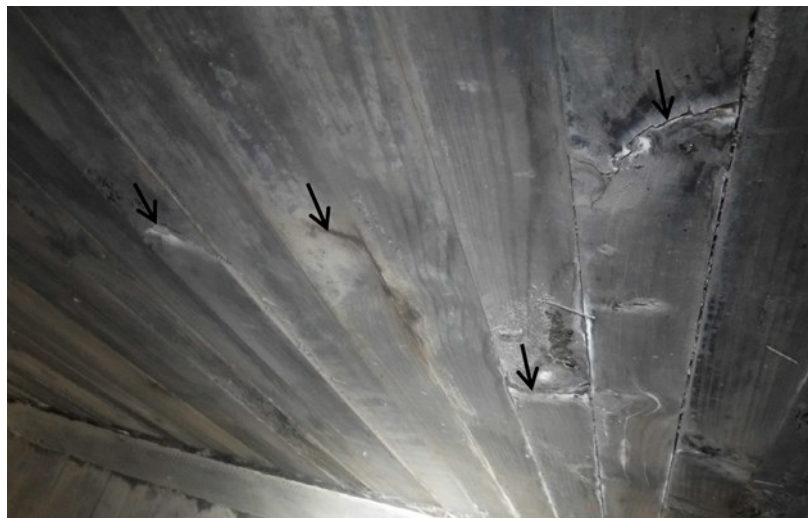
During the latest inspection, the bridge inspector observed cracks in the timbers of the ceiling of the 38-year-old culvert. These cracks required the Berrien County Road Department (BCRD) to restrict the size and weight of vehicles crossing over the culvert.

*Figure 3: Cracks in ceiling of Hill Road culvert prior to repairs*

Berrien County Road Department's Managing Director, Jason Latham, knew this would present a problem for local farmers who would soon need to harvest their crops for the season. Working with The Kercher Group and Scott Civil Engineering Company, the Berrien County Road Department developed an action plan. After a team meeting, it was decided to design steel repair plates to strengthen the cracked timbers. The repair plates were manufactured by BCRD staff in their maintenance shop and installed within a week, allowing the load carrying capacity to be restored enabling safe travel for first responders, the traveling public and farmers.

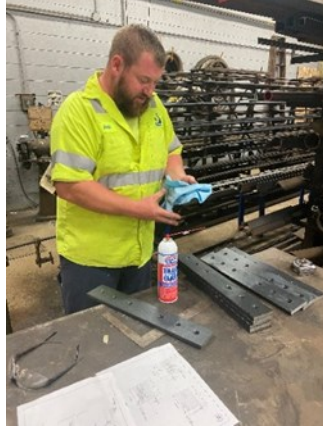
Figure 4: Josh (BCRD) fabricating steel plates in Road Department maintenance shop

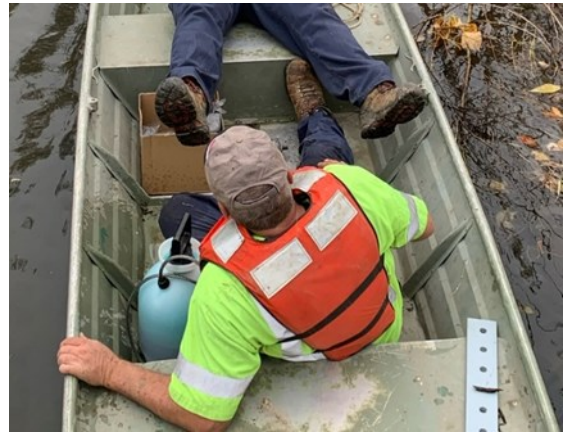
Figure 5: Kurt (BCRD) prior to installing steel plates

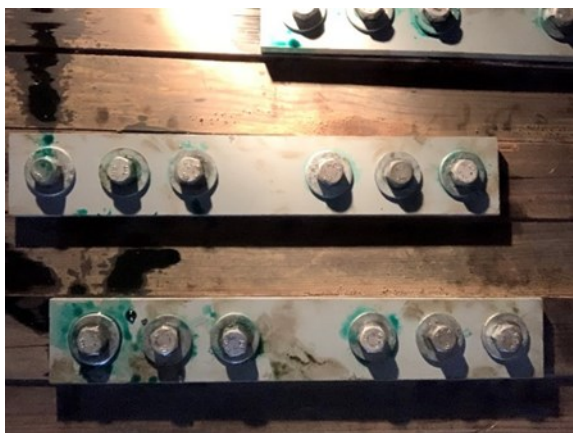
Figure 6: Steel plates installed to timber culvert

“The repairs made to the Hill Road Bridge have enabled the bridge rating to go from poor to fair. This work will provide support to local agricultural businesses, emergency vehicles and school busses that need to use this bridge. The Road Department is lucky to have such a capable workforce to quickly respond to critical safety needs like this.” – Jason Latham

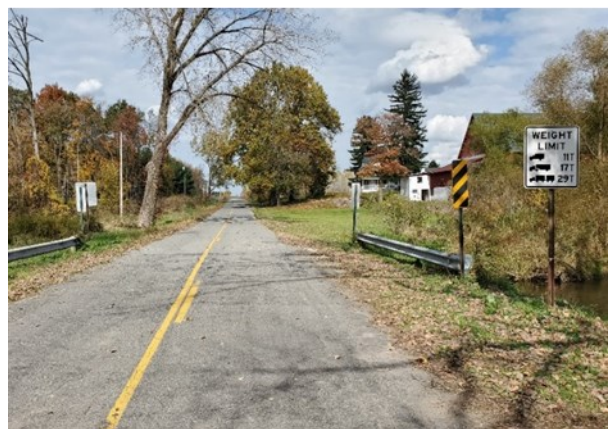
Figure 7: Updated bridge weight limits following repairs
