# Berrien County Road Department Makes Positive Impact with Hill Road Bridge Improvements

**October 27, 2020**

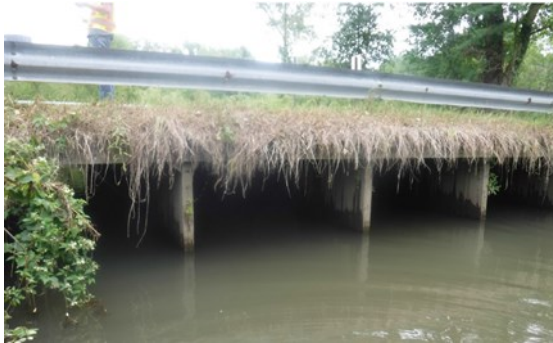
Berrien County has a unique four-cell timber culvert carrying Hill Road over Mill Creek. Highway bridges and culverts over 20 feet in length, like the Hill Road over Mill Creek structure, are inspected for safety and load carrying capacity regularly.

*Figure 1: Hill Road over Mill Creek timber culvert*

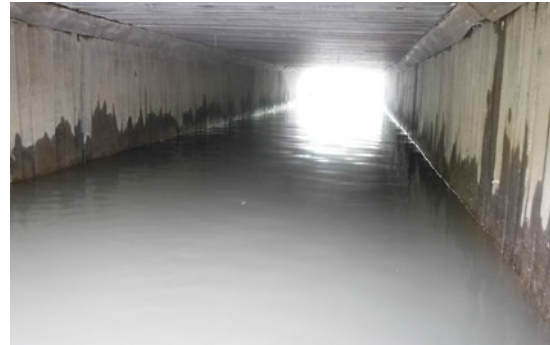
*Figure 2: View from inside the Mill Creek timber culvert*

During the latest inspection, the bridge inspector observed cracks in the timbers of the ceiling of the 38-year-old culvert. These cracks required the Berrien County Road Department (BCRD) to restrict the size and weight of vehicles crossing over the culvert.
